# **Aquatic Habitat Restoration on the Lower Missouri River**

## **Abstract**

### **Case Study: Overton Bottoms Mitigation Site**

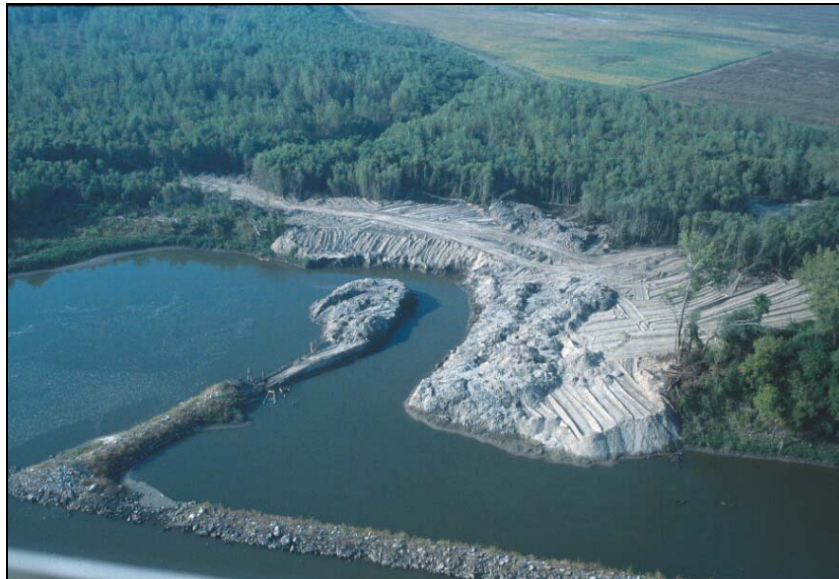
**Figure 4.** Dike notching at Overton Bottoms Mitigation Site

Several other structure modifications have been made at the site. These modifications include large notches, which flank the dike into the bank line. Eight notches have been constructed that are about 50 feet wide, and are typically 4 feet below normal navigation. The surface of these notches has also been irregular to create additional turbulence and bank failure. The intent of these modifications is to allow additional water to flow around the dikes and possibly erode the banks. An example of this work is shown in Figure 4 in a photo that was taken during a low river stage. At higher stages water flows more directly behind the structure towards the bank.
